Installation and Monitoring of Shotcrete Pillars at Newmont Canada's Golden Giant Mine

Abstract

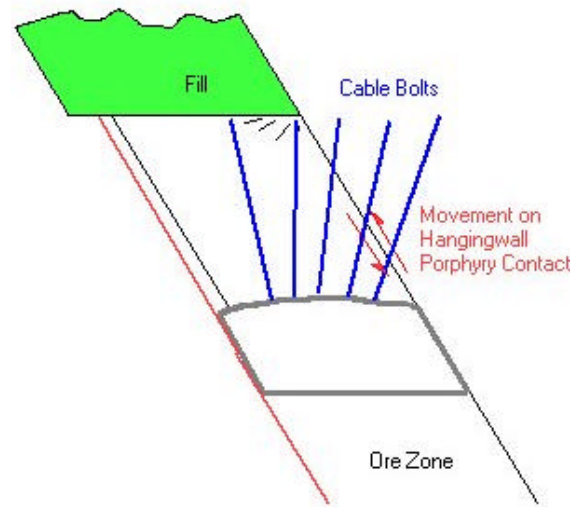
Figure 2. Geometry of failure zone at ore - hangingwall contact.

Failure was attributed to the stress caused by the close proximity of the David Bell sand-filled stopes and the ongoing mining in the Eastern stopes, combined with the contrasting geology between the ore and hangingwall. While the hangingwall is comprised of a competent granite porphyry, the ore is a highly altered sericitic schist. Due to the stress conditions, a series of wedges formed in the sill back. These wedges would slide along the porphyry, appearing as a shear in the sill back (Fig. 2).

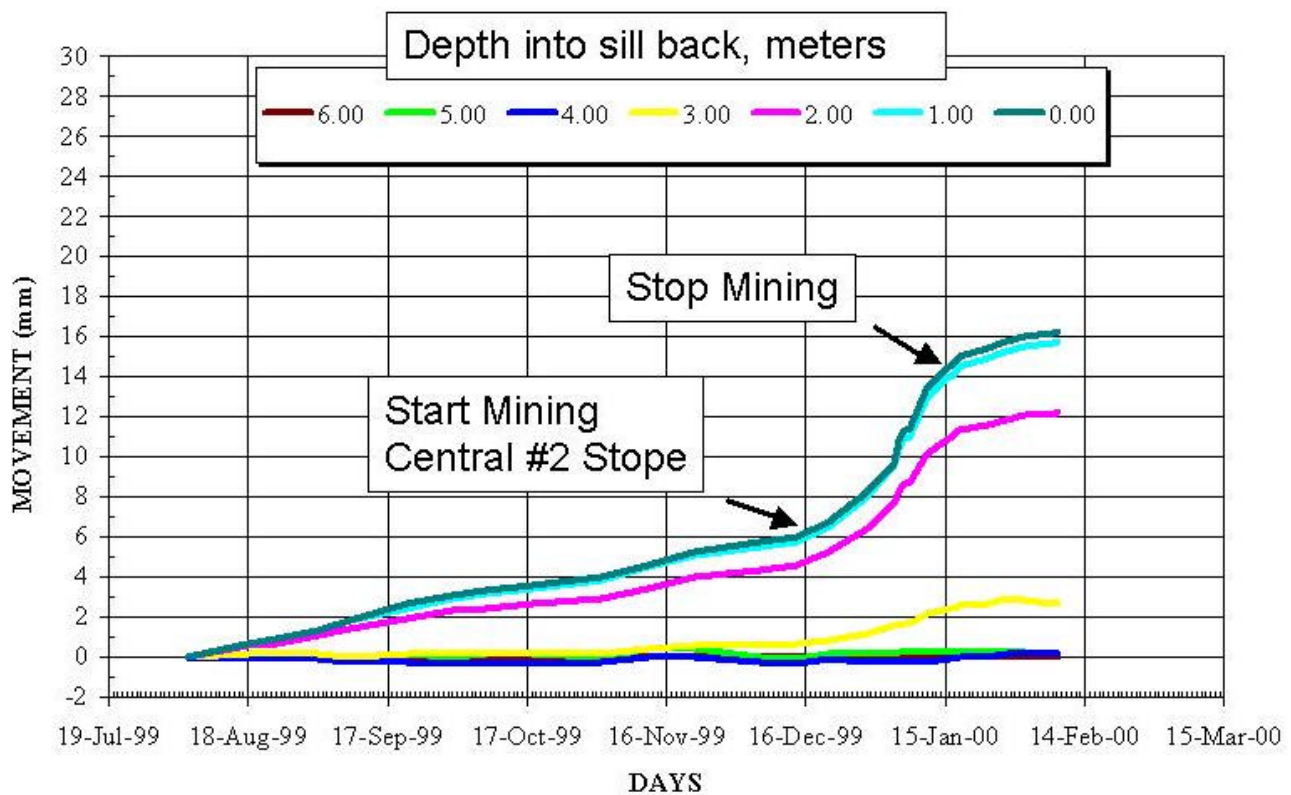
Figure 3. Monitoring data from SMART cable through hangingwall shear.

Shotcrete and cable bolts were installed along the affected sill drives. SMART (Stretch Measurement to Assess Reinforcement Tension) cables were incorporated into the support pattern to monitor the displacement in the back, and the associated load that developed in the cables. Results from the SMART cables indicated a failure zone at a depth of approximately 3 m, which corresponded with the predicted failure mode (Fig. 3).

Mining of the Central stopes began in December 1999. While damage was difficult to assess visually during this time, the installed instrumentation clearly showed the deteriorating support capacity (Fig. 3). During the period between December 16, 1999 and January 7, 2000, convergence in the sill backs became exponential, with rates approaching 1.5 mm per day. It was apparent that the installed support was approaching yield. Mining in Block 5 was halted on January 7, 2000, while support options were evaluated. Based on the results of the analyses, it was decided to install a series of reinforced shotcrete pillars.

It was apparent from the convergence rates from the SMART cables (Fig. 3) that the cable pattern could slow but not fully arrest the movement of the wedge that had developed, so the safety factor for the cable support was assumed to be close to 1. For the shotcrete pillar design, a safety factor of approximately 1.5 was considered desirable. The peak load assumed for the pillar array was therefore calculated to be 18,000 tonnes.

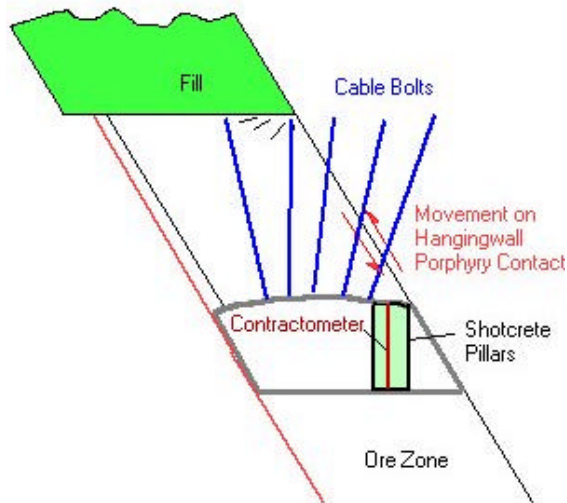
Figure 4. Proposed placement for shotcrete pillars.

1,200 tonnes. To support the 18,000 tonne support capacity, 15 pillars would be required. These pillars were to be placed at 8 m spacing along the length of the 120 m sill. The proposed placement for the pillars is shown in Figure 4.

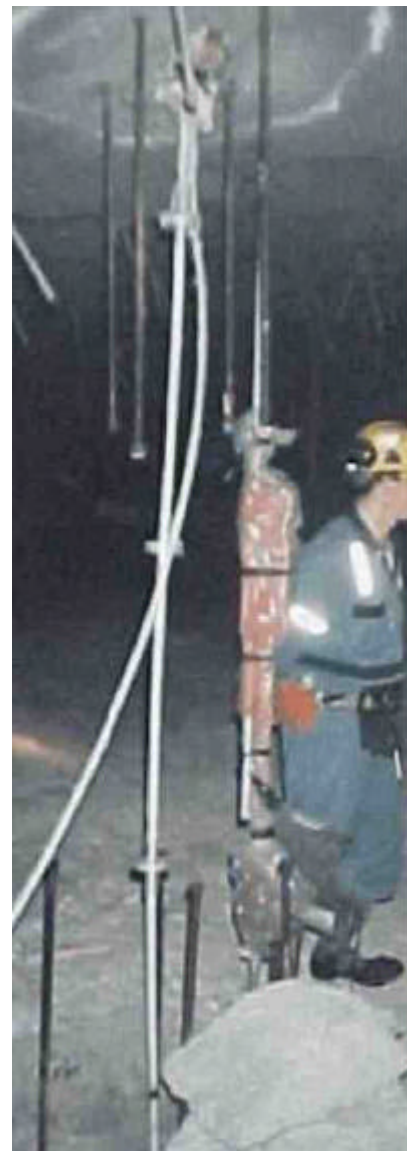
Figure 5. Shotcrete pillar construction showing rebar cage and contractometer.

The shotcrete pillars were constructed by forming a square cage of rebar anchored in boreholes in both the floor and the back (Fig. 5). Each rebar was 4 m long, with 1m protruding from the hole. Additional rebar was tie-wrapped to this rebar to complete the cage. Sono tubes were originally used as forms, but these were found to bulge too easily. A better solution was to use steel half-culverts to form the pillars, with angle

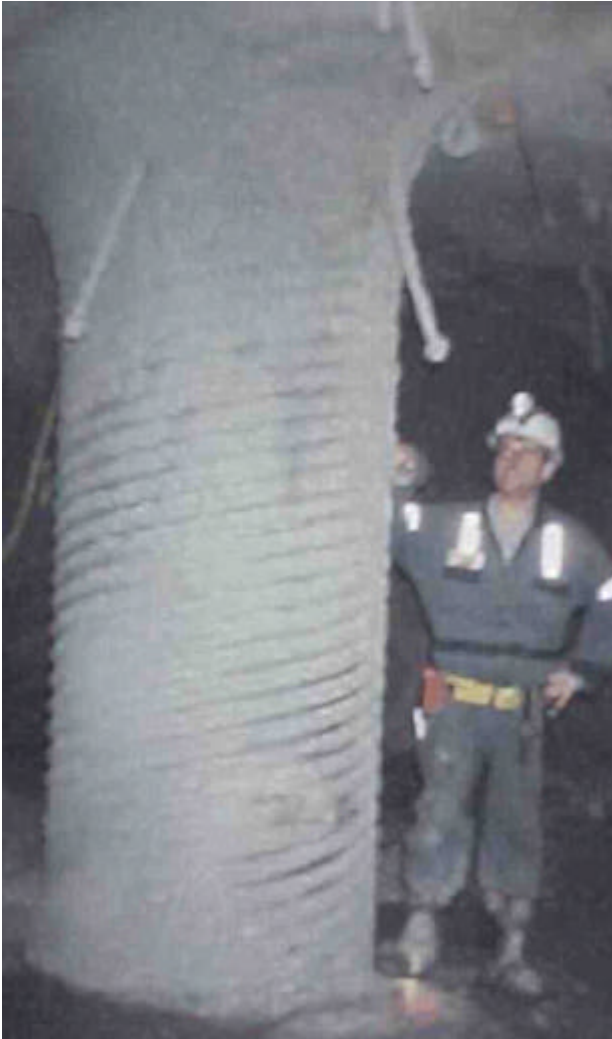
Figure 6. Completed shotcrete pillar.

cases, it was possible to recover the forms from the pillars once the shotcrete had cured. Shotcrete was then sprayed around the top and base of the pillar to enhance the bond between the pillar and the floor and back. A completed shotcrete pillar is shown in Figure 6.

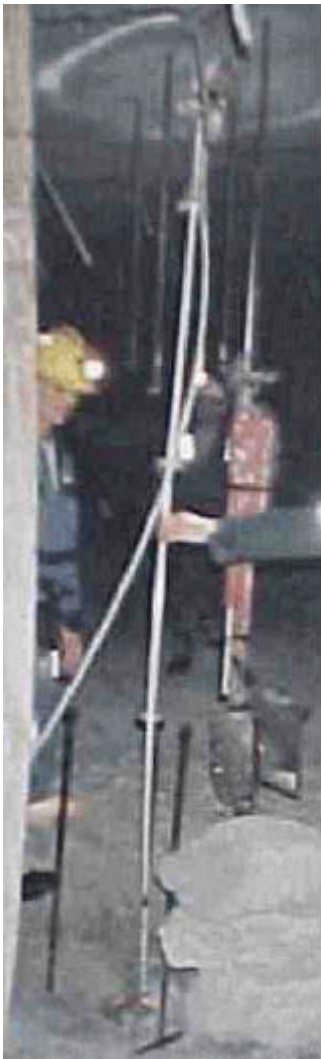
Figure 7. Contractometer installation prior to forming and shotcrete placement.

Installation of the Contractometers is shown in Figures 7 and 8. Shear washers were used on each anchor to ensure that the displacement of the shotcrete pillars was transferred to the instrument. Due to the amount of movement expected, 190.5 mm (7.5 in.) potentiometers were installed in these instruments, providing 95.3 mm (3.75 in.) of extension or contraction within the instrument. Contractometers were installed in every fourth pillar in the pillar array – two in the 4217 sill, and two in the 4225 sill.

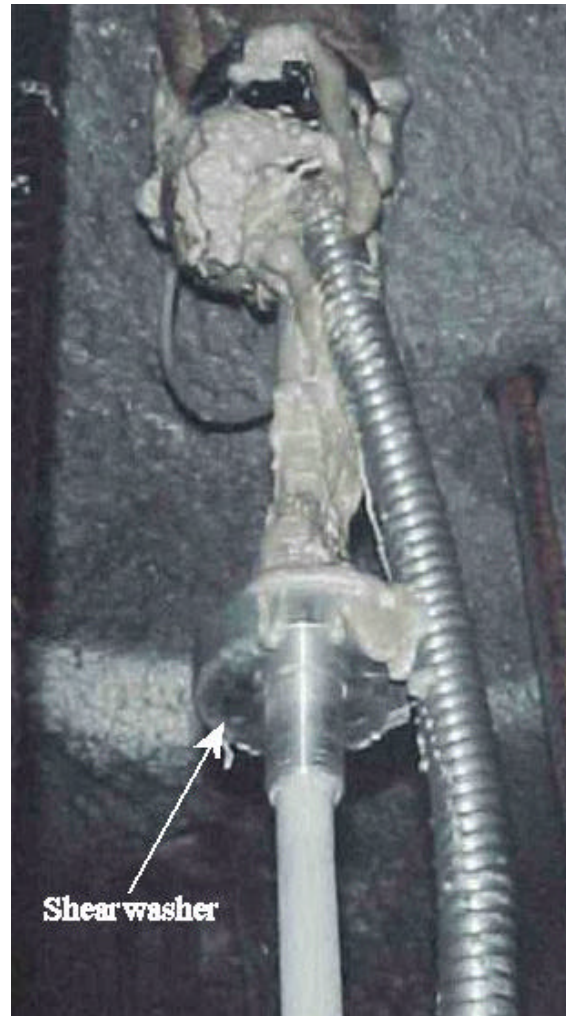
Figure 8. Closeup of Contractometer installation in stope back showing foam used to fix instrument head and last anchor in the hole. Note the use of shear washers on the anchors within the shotcreted portion of the pillar.

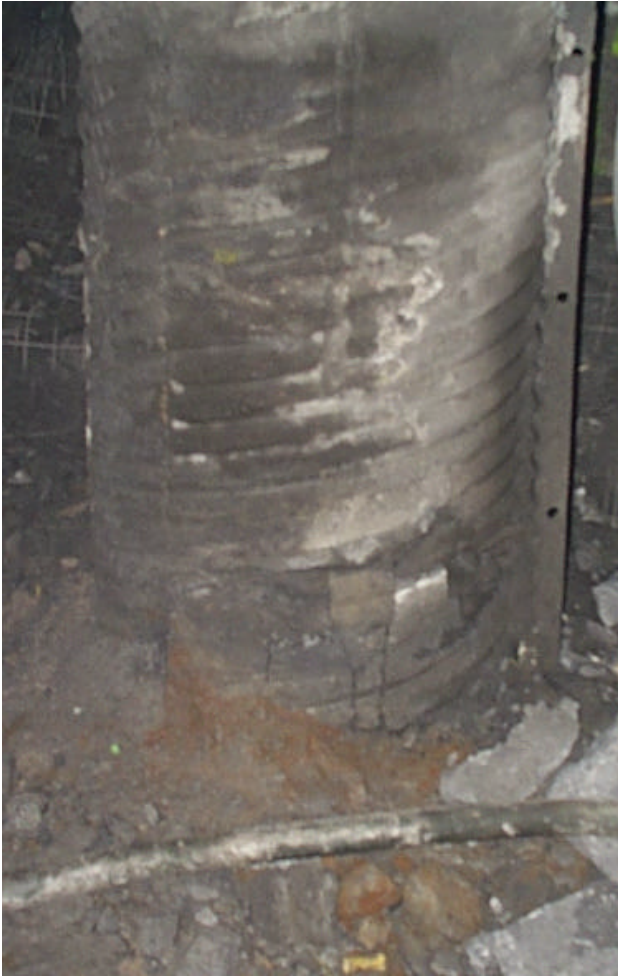
Figure 9. Crack monitoring of shotcrete pillars during mining. Failed areas marked with red paint.

Monitoring of all instrumentation (Contractometers, SMART cables and MPBX's) was carried out during the extraction of the sills. In addition, regular visual inspections of the shotcrete pillars were conducted. Cracks in the pillars were painted and dated to identify the movement in the pillars on a shift-by-shift basis (Fig. 9).

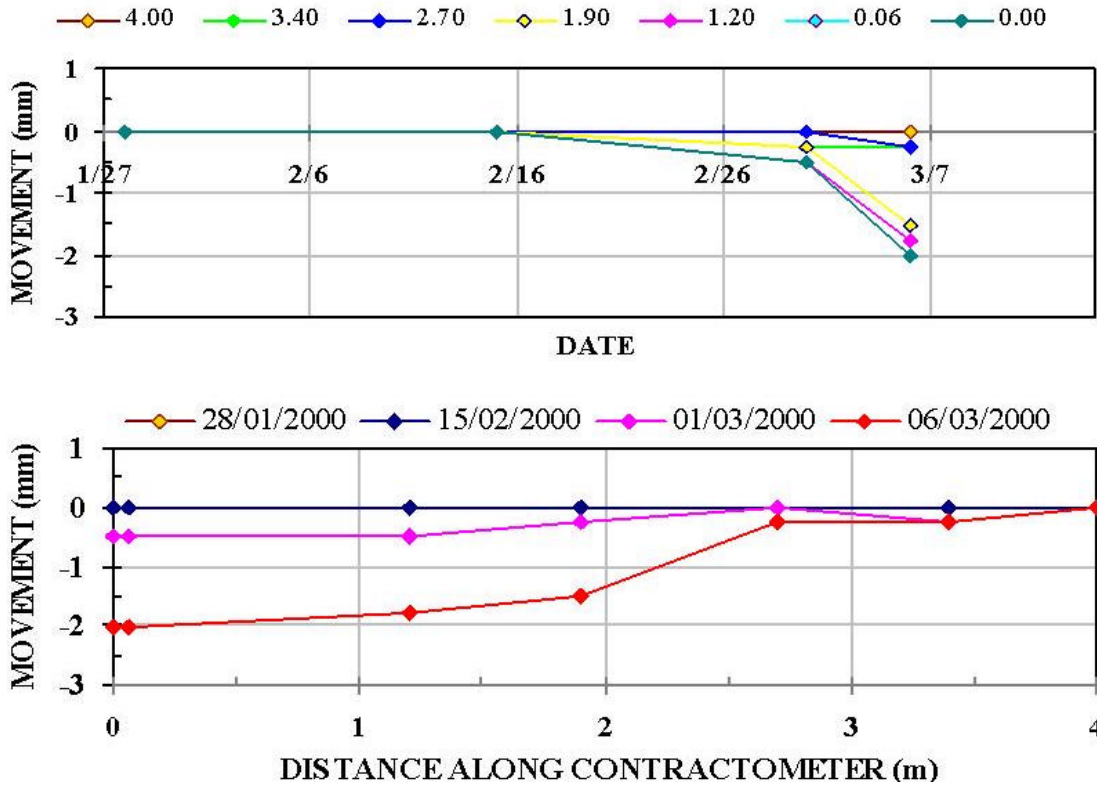
4225 Pillar 3 - C010006

Figure 10. Data plots for Contractometer C01006 showing a.) movement vs. date, and b.) movement vs. distance.

The displacement versus time plot for this instrument is shown in Figure 10a, where it can be seen that the upper 2 m of the shotcrete pillar are beginning to compress. The displacement versus distance plot (Fig. 10b), which shows the amount of closure at each anchor location, shows the same trend. The ground around this pillar was mined early in the sequence for the 4225 sill, so little data is available. Only about 2mm of compression was observed prior to destruction of the pillar.

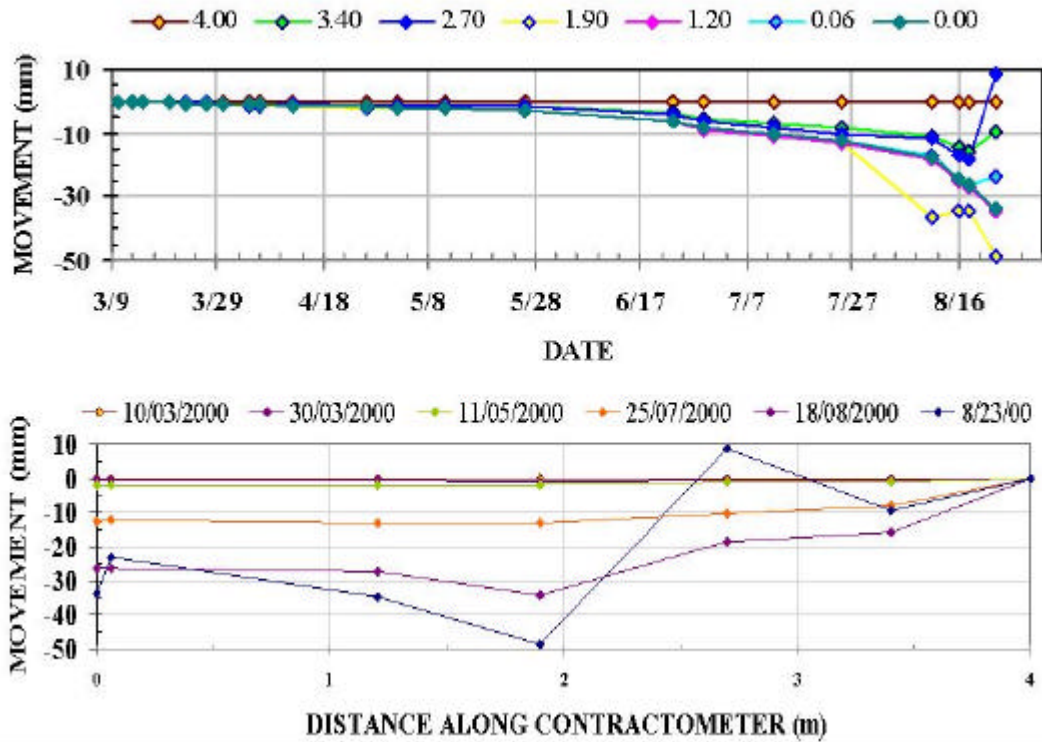
4225 PILLAR - C010004

Figure 11. Data plots for Contractometer C01004 showing a.) movement vs. date, and b.) movement vs. distance.

The displacement versus time plot for this instrument (Fig. 11a) shows increasing compression of the pillar with time. The compression begins to accelerate after August 11. The instrument shows some buckling of the pillar at about 1.9 m from the instrument head. However, failure of the pillar begins to occur between August 18 and August 23. As the pillars crush, pieces begin to spall off. When the spalling reaches the location of the Contractometer, the movement changes from compressive (crushing) to extension (tension) as the block containing the anchor moves away from the core of the pillar due to buckling. This can be observed in the lower portions of the pillar (between 2.7 and 4.0 m). From

the displacement versus length plot (Fig. 11b), significant compression of the pillar can be seen between July 25th and August 18th, with most of the compression occurring within the upper 2 m of the pillar. After August 18, failure of the lower portion of the pillar occurs; however, this failure occurs at the anchors below 1.9 m (2.7 and 3.4 m).

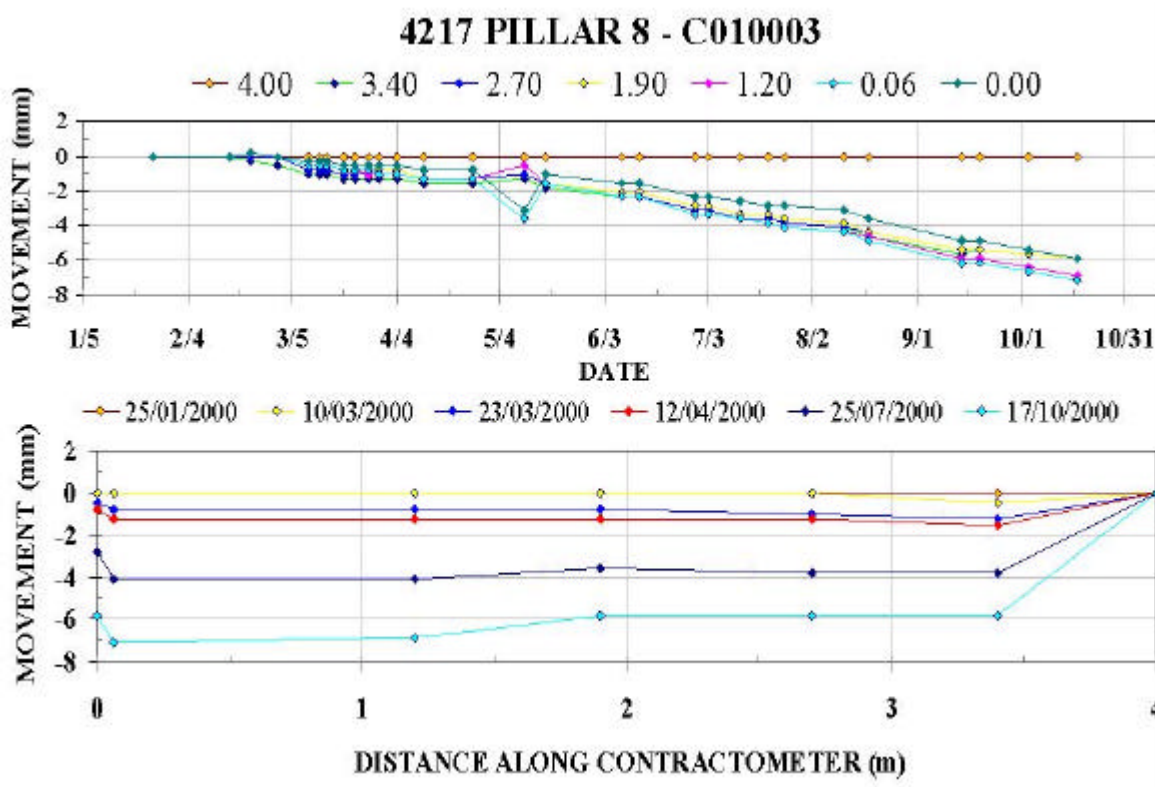
Figure 12. Data plots for Contractometer C01003 showing a.) movement vs. date, and b.) movement vs. distance.

Steady closure of this pillar is observed on the basis of the displacement versus time plot (Fig. 12a) for this instrument. The displacement versus length plot (Fig. 12b) shows an increase in the compression of the pillar, with movements occurring uniformly throughout the pillar. The rate of compression begins to increase after April 12; however, the pillar does not undergo failure prior to being removed. The total amount of compression in this pillar is on the order of 7 mm.

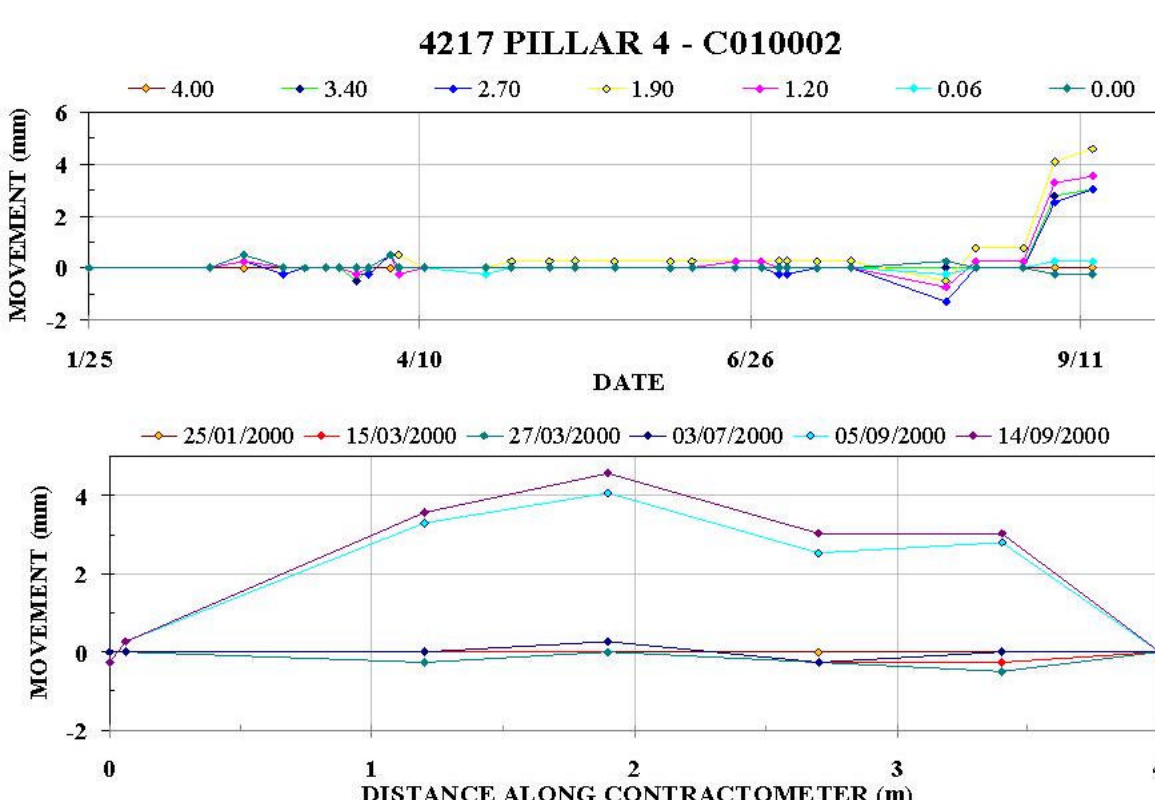
Figure 13. Data plots for Contractometer C01002 showing a.) movement vs. date, and b.) movement vs. distance.

The displacement versus time plot for this instrument, shown in Figure 13a, suggests that the pillar is stable, assuming little or no load prior to August 11. On this date, the pillar experiences some compression, focused mainly between about 1.0 m and 2.7 m (the midpoint of the pillar). After the August 11 reading was taken, the pillar appears to undergo some bulging at its midpoint. These trends are echoed by the displacement versus length plots (Fig. 13b), which show a maximum movement of 4mm tension at the midpoint of the pillar.

process, and ended up located very close to the wall of the shotcrete pillar. Consequently, the instrument would reflect any bowing of the pillar sides experienced during loading, manifested as tensile readings while the overall pillar movement was compressive. The movements also indicate that the foam adhesive used to anchor the instrument in the back of the excavation was ineffective, and that the head had moved during construction.
